Chapter 6

ANALYSIS OF BUILDING EGRESS

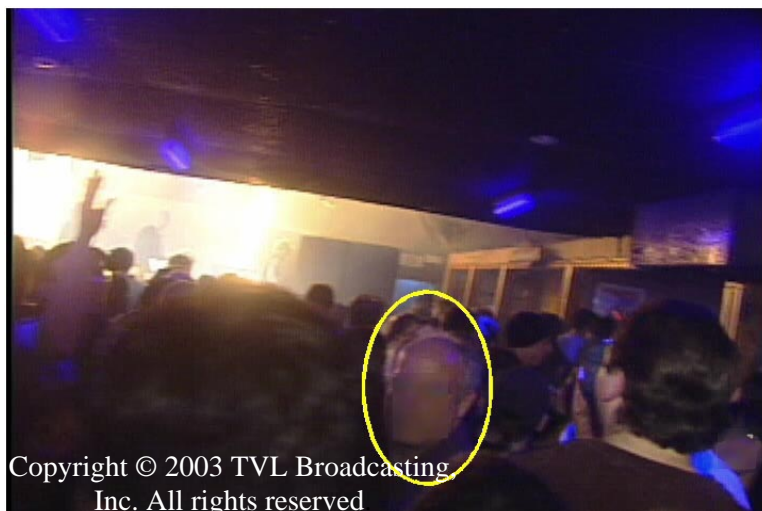
Efforts were made to track individuals from their location in the club when the fire ignited until they had evacuated. One male occupant, shown facing the camera in Figure 6-1, was tracked through evacuation. The time of this still frame is 0:06:51 video time (0:00:29 fire time). The occupant's face has been blurred in the figures below in order to preserve his anonymity; his facial features were not critical for the identification analysis.

Figure 6-1. Occupant at Start of Evacuation [2]

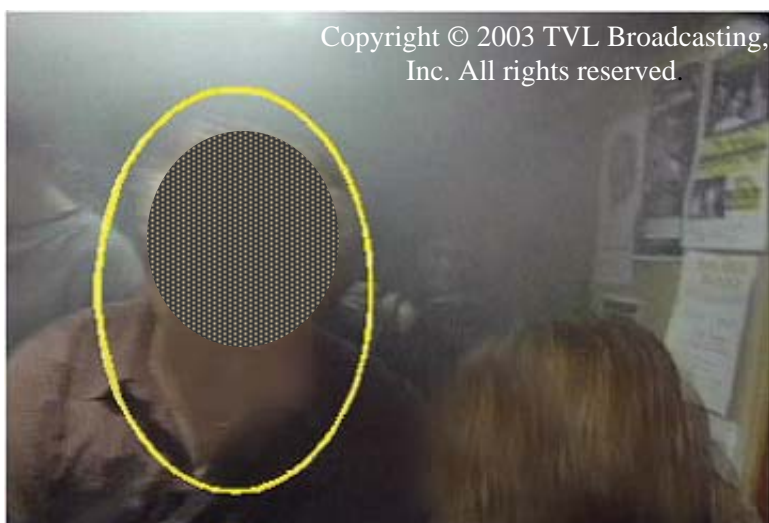
After the ignition of the fire, the camera operator began moving towards the main exit before most other occupants did. The camera passed the occupant shown in Figure 6-1 before this individual had begun to evacuate, and he can be seen still facing the platform. At 29 seconds after the ignition of the fire, this individual was seen to turn and to begin moving towards the door. At this point, the camera was approximately two rows of people behind this man (between him and the main exit). This occupant can be seen reaching and crossing the main exit at 0:07:31 video time (0:01:09 fire time), 39 seconds later, in Figure 6-2.

Figure 6-2. Occupant Exiting the Building [2]

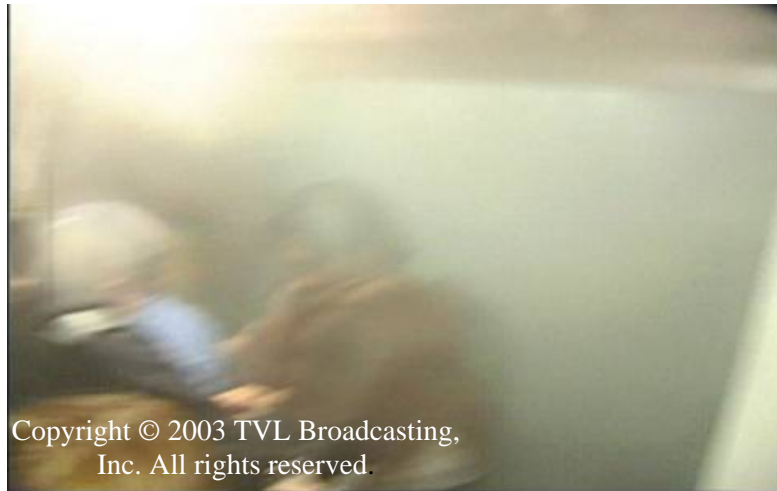
Although Figure 6-3 is of poor quality because the camera was in motion at the time, this video frame depicts a series of occupants evacuating through the main exit (note that the white surface at the lower right corner of the frame is one of the open exterior doors). The video time of this still frame is 0:07:33 (0:01:11 fire time). A male and a female are visible near the center of the frame; however, occupants cannot be seen immediately behind them. It would be expected that the occupant density ahead of these

Figure 6-3. Evacuating Occupants [2]

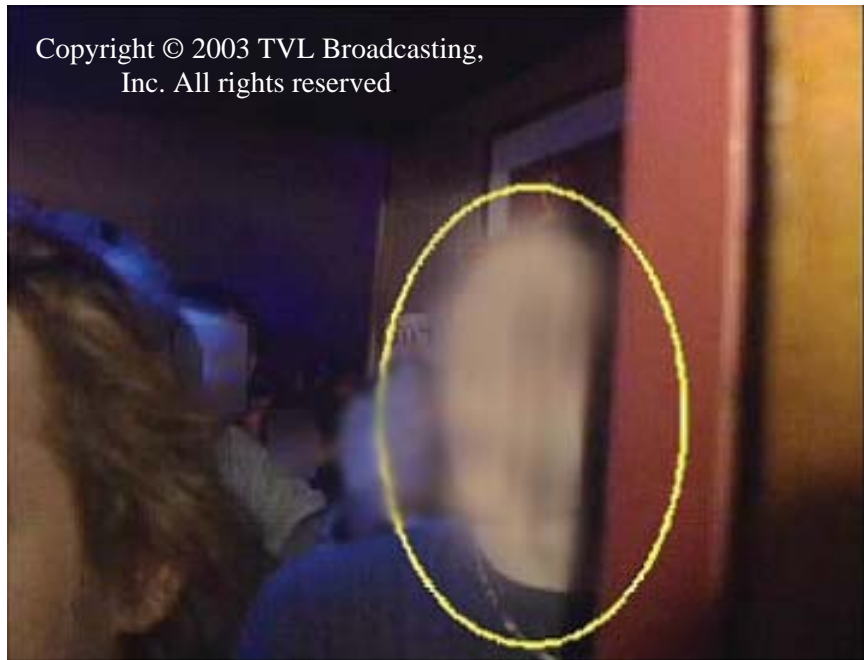
Figure 6-4 Occupant Attempting to Evacuate [2]

Forty-one seconds elapsed between Figure 6-4 (0:01:02 fire time) and when the occupant was first seen near the bottom of the pile. Because the camera operator moved to the side of the building immediately upon exiting through the main exit, it is not known when the individual shown in these figures reached the door and fell to that position.

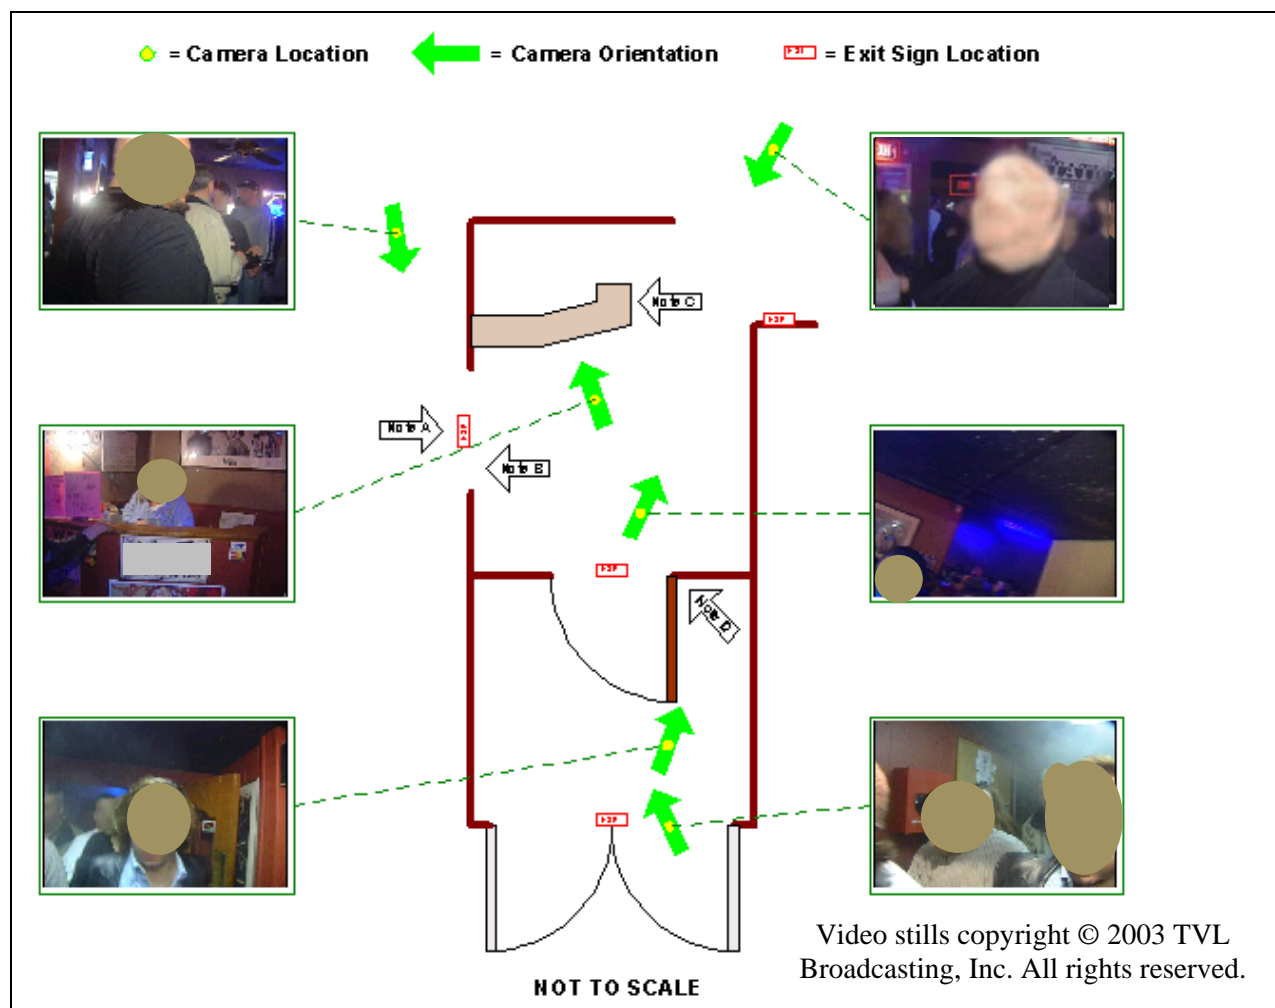
Figure 6-12. Detail of Main Exit Vestibule Area (Video frames copyright © 2003 TVL Broadcasting, Inc. All rights reserved)

Note A: Photograph or video evidence specifically showing the exact location of this exit sign above the secondary vestibule doorway was not available. However, the sign was observed in the WPRI video in a reflection in the mirror behind the main bar.

Note D: The dimensions of the associated sidelights are not known, although the orientation shown here is accurate based upon video evidence. Note that the single inner door provides the limit to egress, not the exterior double doors.

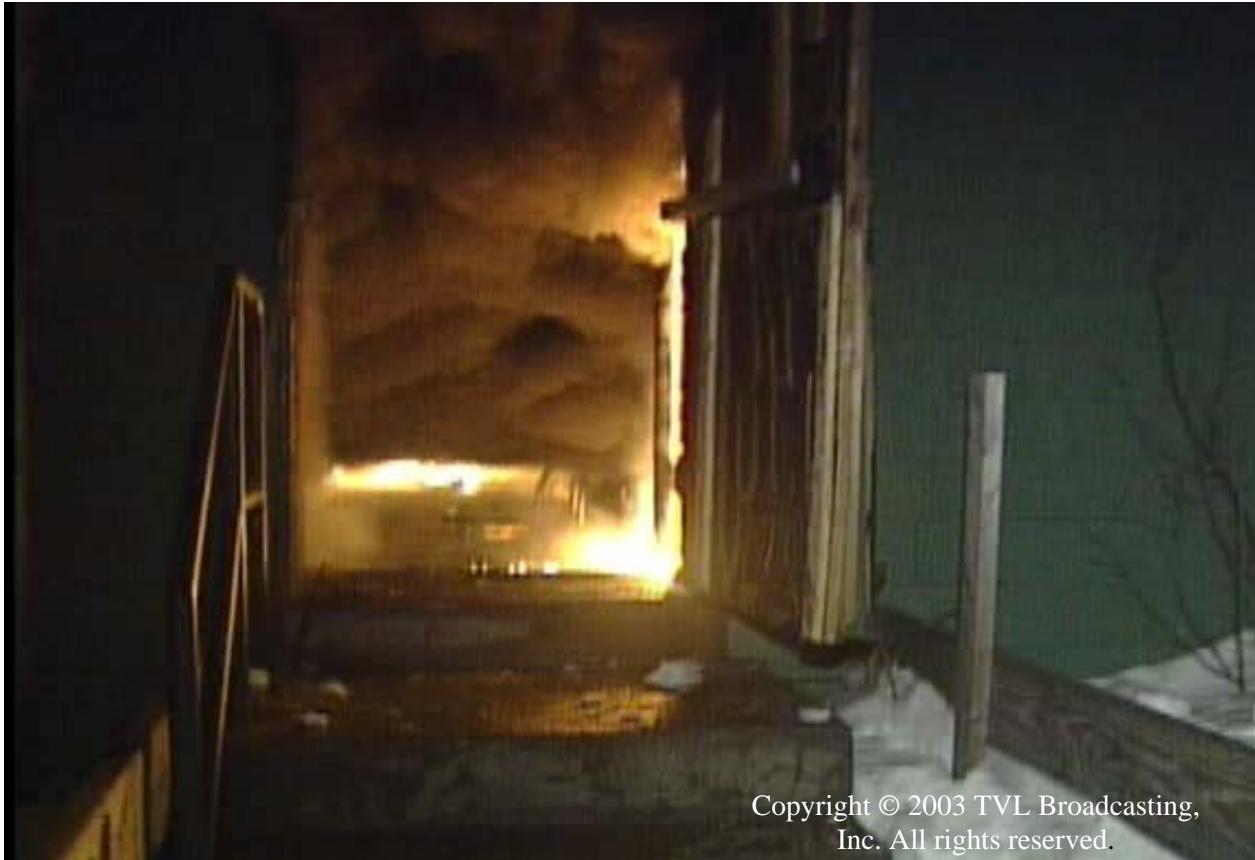
- Platform exit door swings in the wrong direction;
- Panic hardware on platform door is broken.

Figure 6-13. Exit Door Near Platform [2]

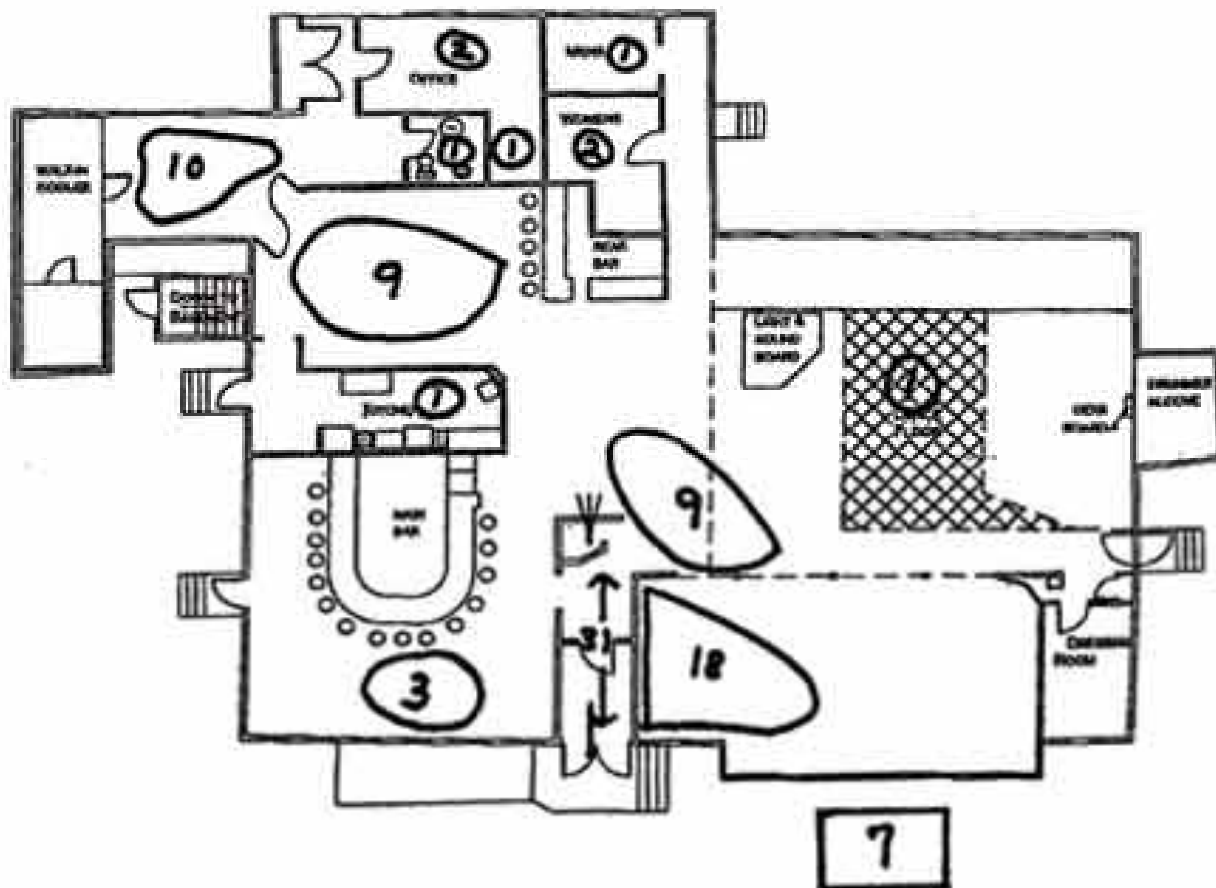
The Rhode Island Attorney General's office released a diagram of the approximate location where the rescuers recovered the 96 people who died at the scene of the fire [36]. (See Figure 6-14.) Based upon interviews with witnesses reported by the *Providence Journal* and the distribution of the victims shown in Figure 6-14, about 2/3 of the occupants appear to have attempted to leave through the main entrance in the front of the building; however, only about 40% of those who successfully evacuated escaped through the main entrance.

Figure 6-14. Location of Recovered People Who Died at Scene [36]

The small number of victims found in the main bar room suggests that the main bar room exit door and windows provided open routes to escape for a time period about as long as it took to reach untenable

conditions in that area of the building. By contrast, the high number of victims found in the sunroom relatively close to the windows suggests that the environment there became untenable quickly, eliminating the option of a secondary route through the sunroom windows once the platform door and main entrance became unusable. Both of these conclusions are consistent with the environmental conditions predicted in the FDS simulations discussed in Chapter 5.

A significant number of victims were found in the dart room, storage area, and office, suggesting either that they were unfamiliar with the building and hoped to find a safe exit in that region, or that they became disoriented while heading for the side exit of the main bar room (or possibly the kitchen exit). It is unclear whether the seven people identified in Figure 6-14 as being recovered from the front of the building outside of the sunroom died as they escaped or were pulled from the sunroom by rescuers.
